FORD HELPING POLICE DEPARTMENTS REPAIR MODIFICATION ISSUES IN POLICE INTERCEPTOR UTILITY VEHICLES

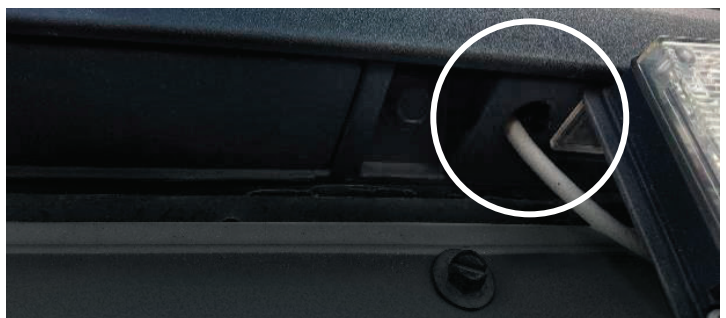
Close up of after-market light and wiring.
